Assessment of Dam Safety of Coal Combustion Surface Impoundments

Indianapolis Power & Light Company

Harding Street Generating Station

November 15, 2010

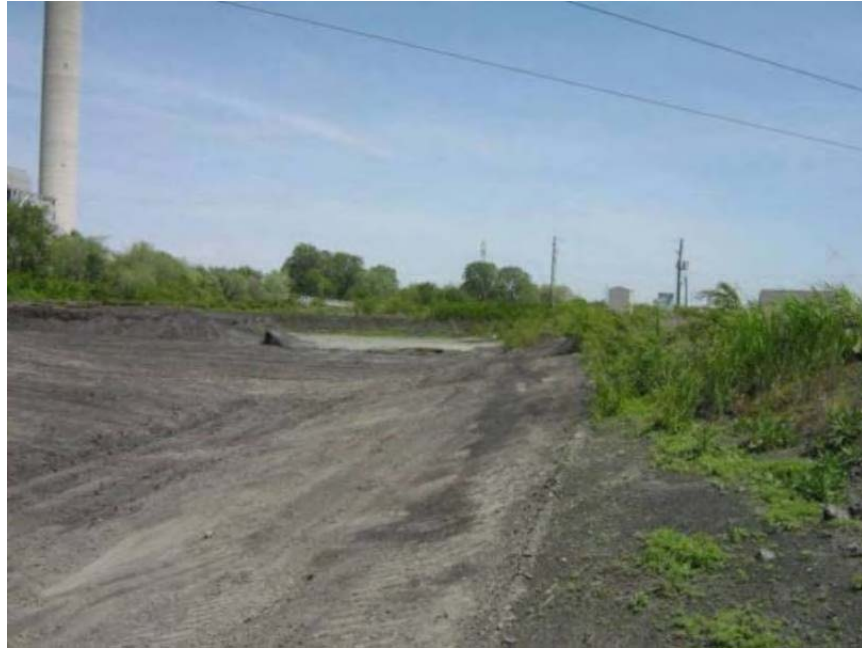
3. Ash Pond 1 - South Embankment Interior Slope, Looking East

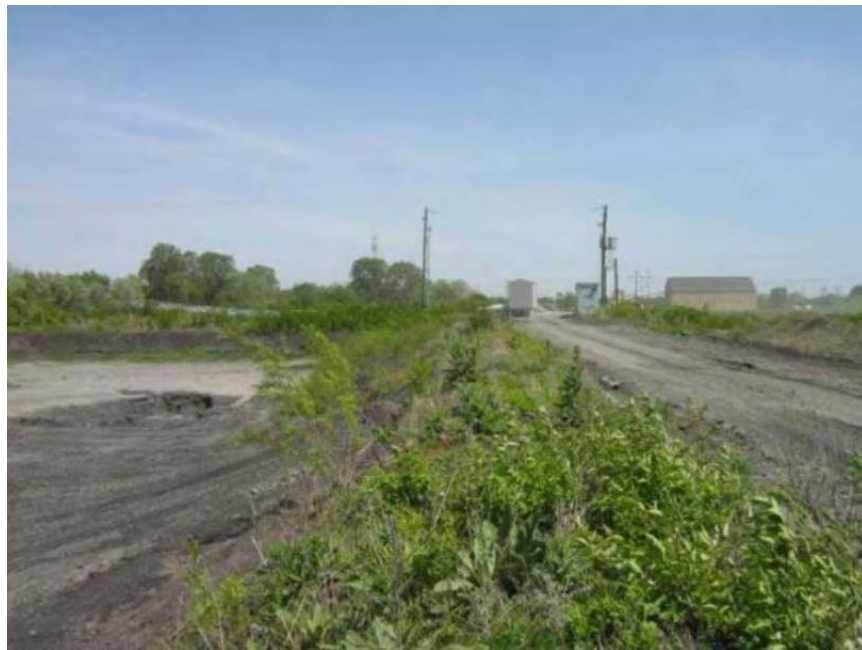
The interior slopes appear to be in fair condition. Light vegetation covers the south and east embankments (Photographs 4 and 9). The interior slopes are approximately 3H:1V. No armoring of the interior slope is present, and much of the pond's interior surface consists of exposed ash. Areas of beaching and erosion were observed on portions of the unprotected slope surface (Photograph 16). Beaching is defined as the progressive erosion of the interior embankment slope caused by repeated wave action

4. Ash Pond 1 - Vegetation on South Embankment Interior Slope,
Looking East

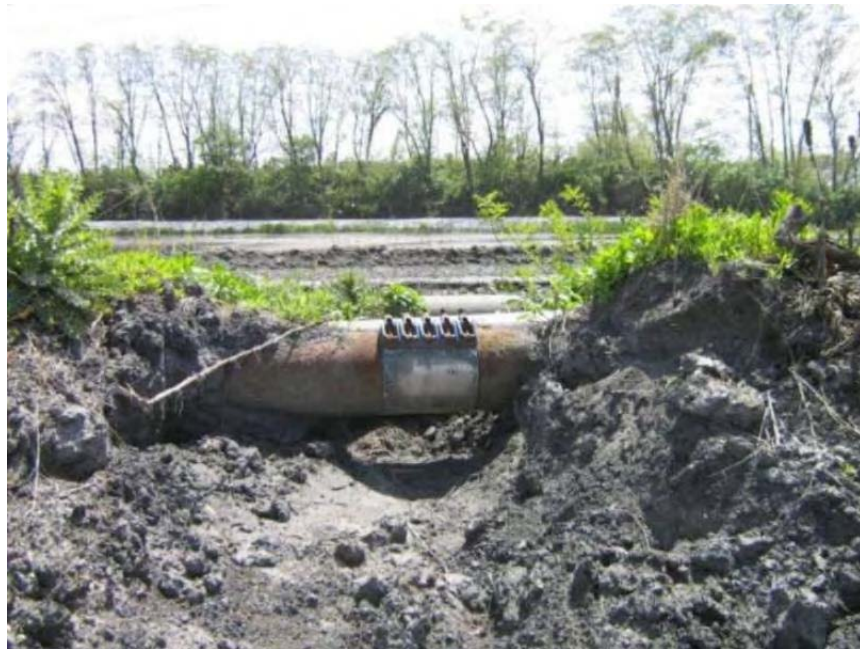
The crest of Ash Pond 1 appeared to be in satisfactory condition (Photographs 1, 8, 11, and 12). The crest was approximately 15 feet wide with the exception of the haul road portion of the crest on the north embankment that was approximately 20 feet wide. The entire crest is exposed to vehicle traffic. Depressions and minor ruts, apparently due to vehicle traffic, were observed on the crest of each embankment (Photograph 1, 8 and 12). The crest surface appears to consist of compacted granular soils. A section of the crest of the south embankment has been excavated and remains open, apparently to facilitate the repair of a joint on the cinder pit sluice line (Photograph 5).

5. Ash Pond 1 - South Embankment Crest, Repaired 8 inch Diameter Sluice Line

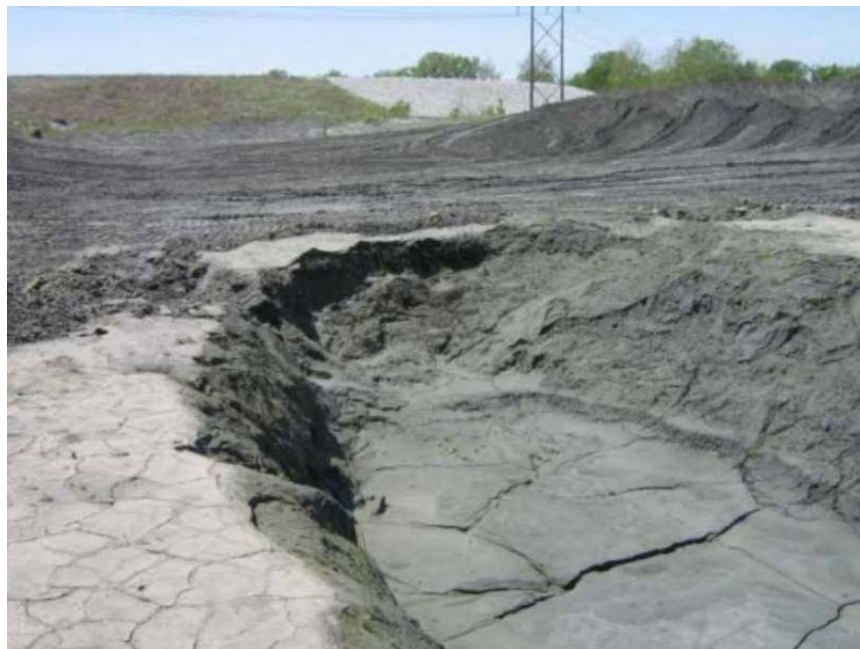
6. Ash Pond 1 - Excavation of Basin Floor (Approximately 6 feet deep, 55 feet long, 30 feet wide)

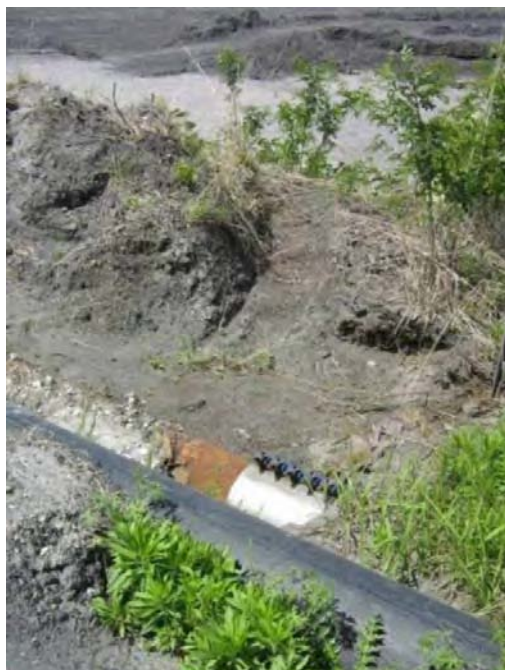
7. Ash Pond 1 - Sluice Line Repair at South Embankment Interior Slope

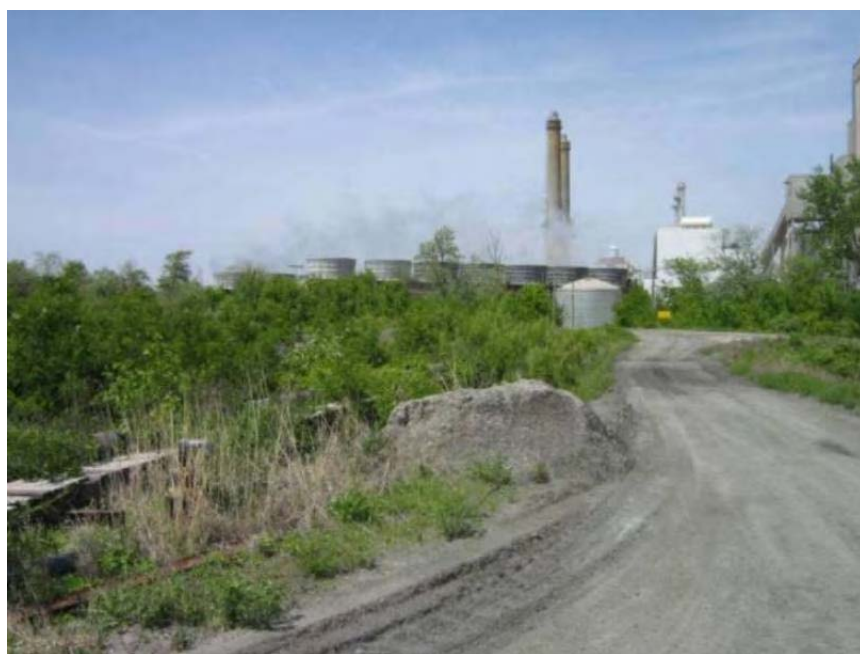
8. Ash Pond 1 - East Embankment Crest, Looking North

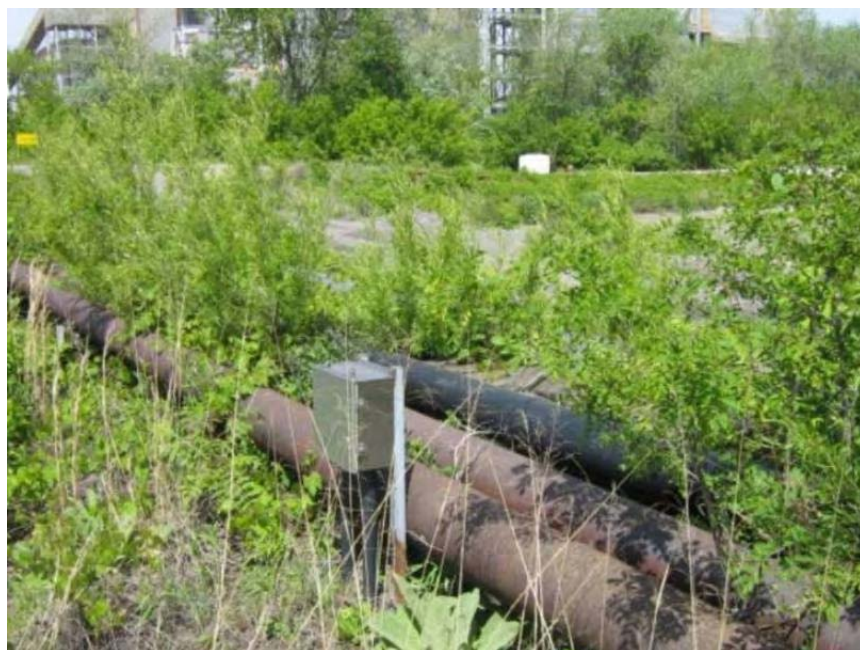
10. Ash Pond 1 - East Embankment Crest with Four (4) 8-inch-Diameter Sluice Lines and Vegetation

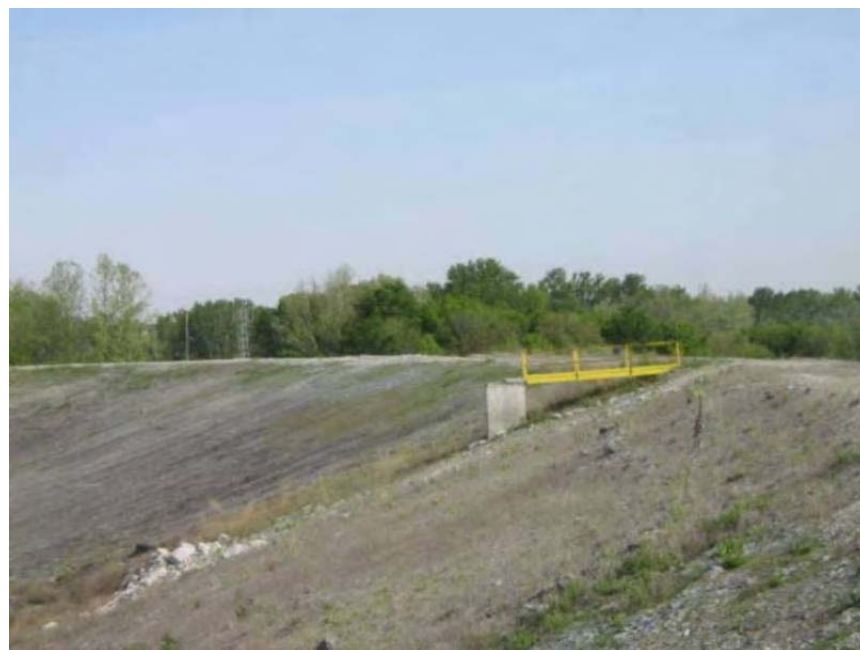
21. Ash Pond 2 - Outlet Structure on East Embankment Interior
Slope, Looking North

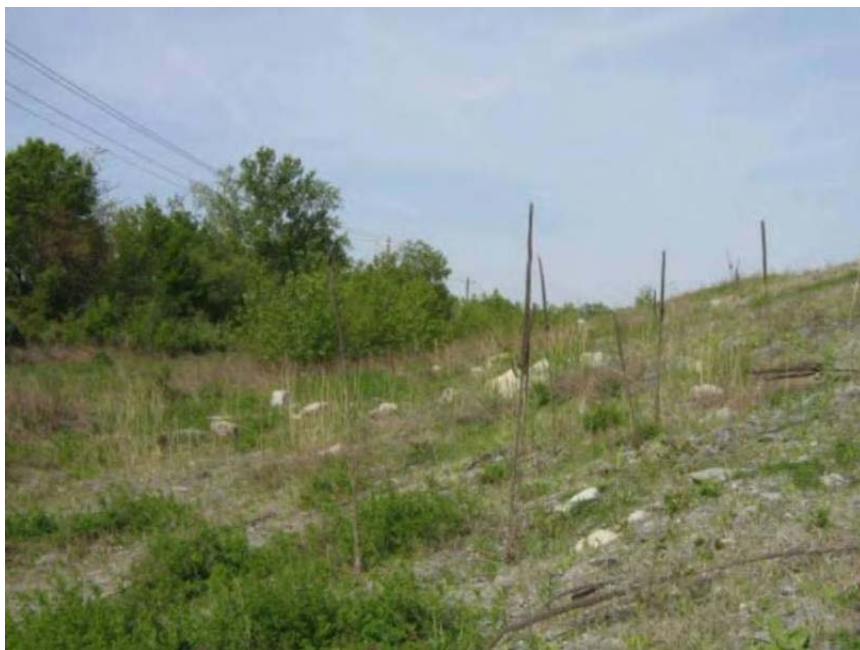
23. Ash Pond 2 - South Embankment Exterior Slope, Looking North, Vegetation Located at on Slope and Toe

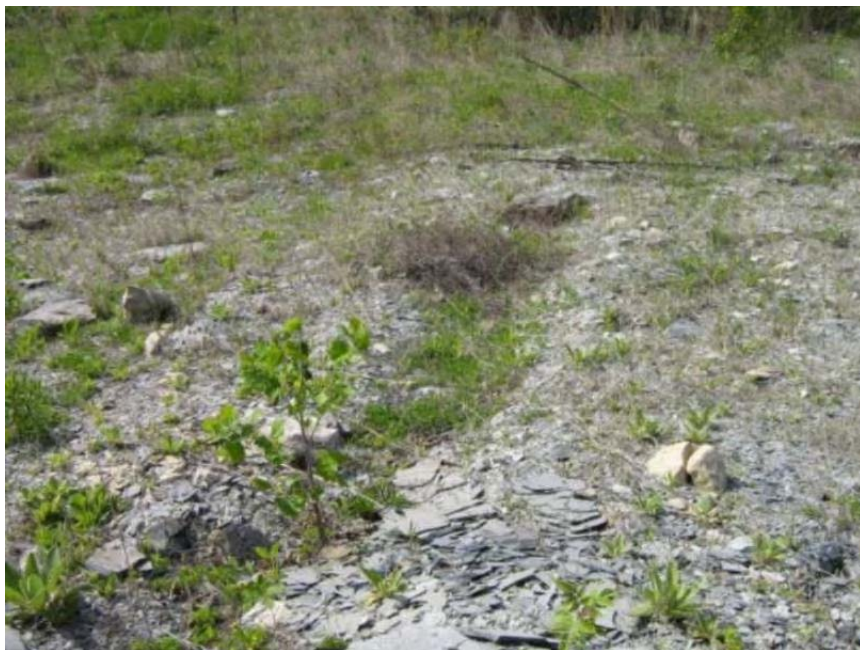
The exterior slopes of the impoundment are approximately 3H:1V. The slopes appear to be in fair condition. The south embankment slope is generally covered with weathered shale fill. Numerous erosion rills were present on the exterior slope of the south embankment (Photographs 25, 27, 29, and 32). Vegetation including brush and saplings (up to 3 inches in diameter) were observed along the toe of the south embankment (Photos 22 and 23). Riprap has been placed over a geotextile in 3 locations on the south embankment (Photos 28 and 29). The riprap appears to be remediation efforts in the vicinity of erosion rills, previously documented in BT SQUARED, Inc. (BT SQUARED) and Geosyntec's September 2008 inspection report.

25. Ash Pond 2 - Erosion Rill on South Embankment Exterior Slope

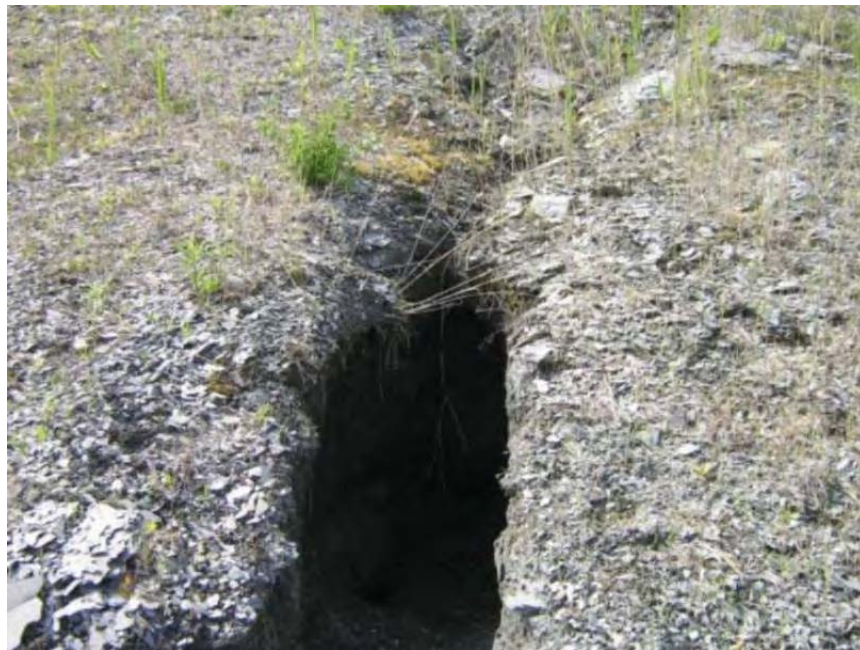
The interior slopes appear to be in generally poor condition. The interior slopes are approximately 3H:1V. No armoring of the interior slope is present and much of the pond's interior surface consists of exposed ash. There are deep erosion rills and significant surface sloughs on approximately 40 percent of the south embankment interior slope (Photographs 26, 33, 34 and 35).

33. Ash Pond 2 - Deep Erosion Rill on South Embankment Interior Slope

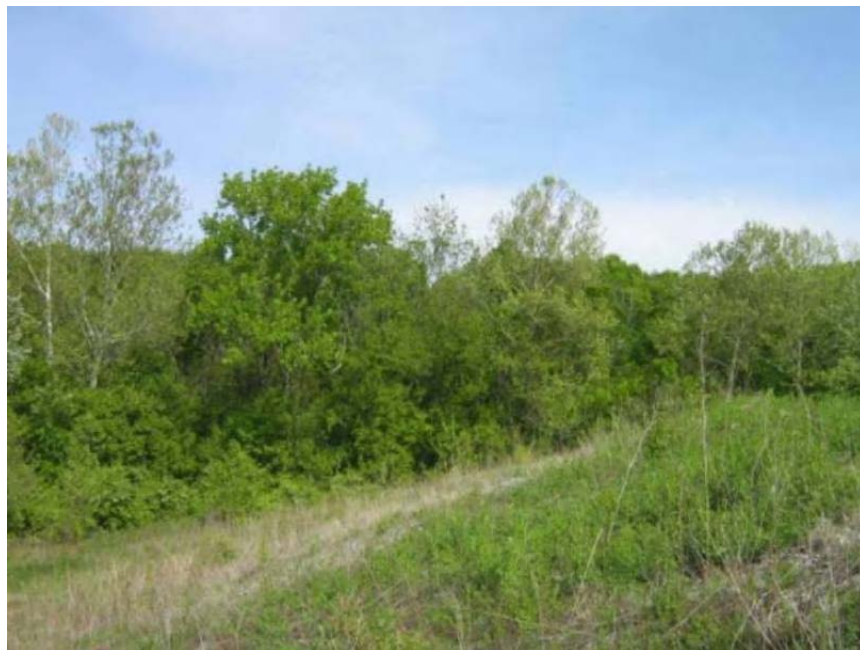
37. Ash Pond 2 - West Embankment Interior Slope, Looking North
(Slope is approximately 3H:1V)

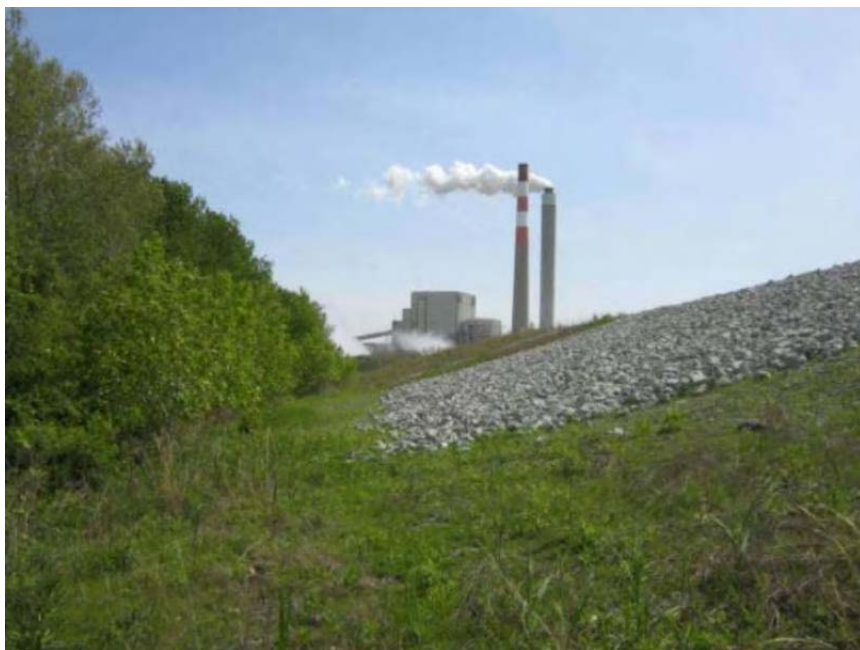
39. Ash Pond 2 - North Embankment Exterior Slope, Looking East

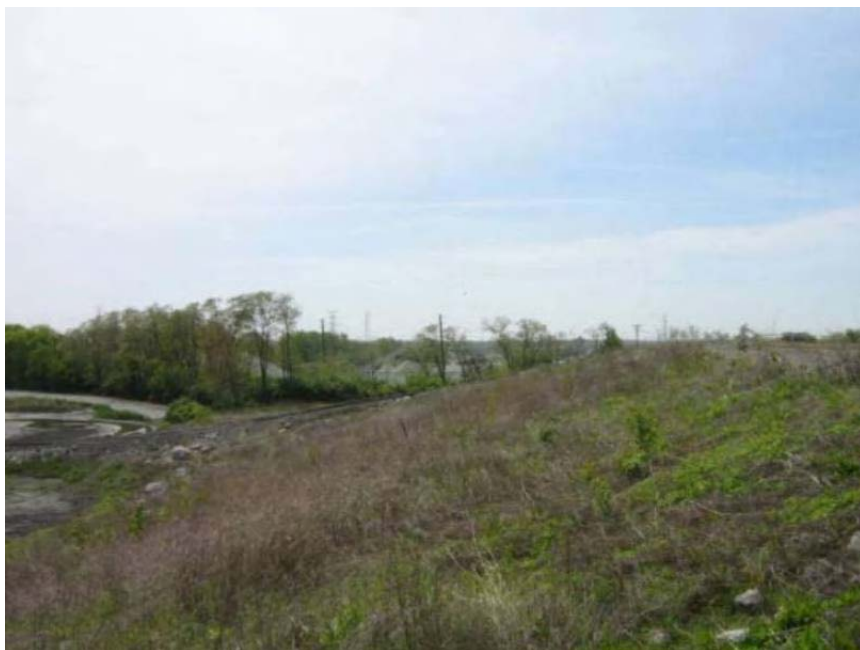
45. Ash Pond 2 - East Embankment Exterior Slope, Looking South

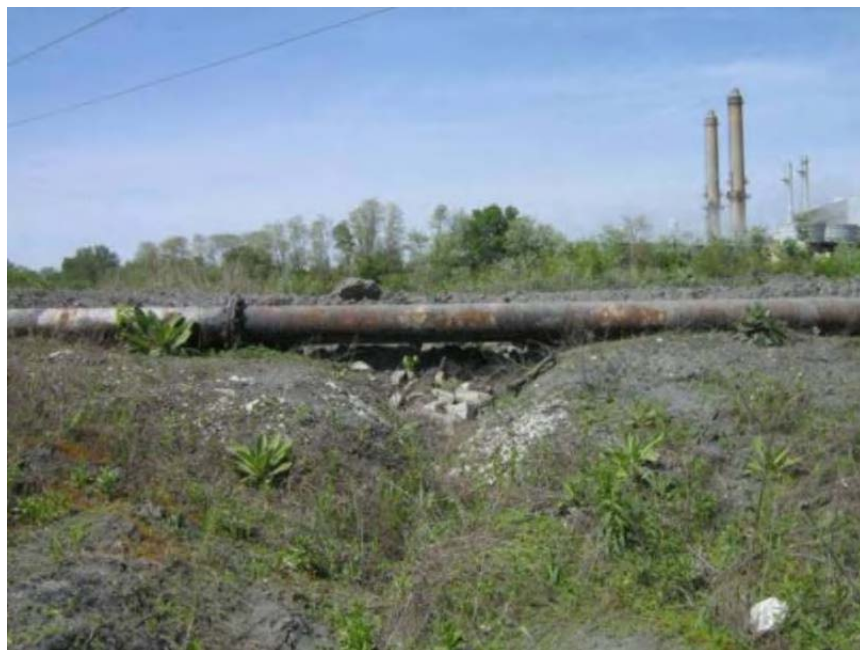
The interior slopes appear to be in fair condition. Erosion rills were observed along the north embankment. Erosion has undercut two active sluice lines in one location along the north embankment (Photographs 48 and 49). Riprap has been placed in several locations along the north embankment (Photograph 46), but in general the surface of the interior slopes defining Ash Pond 2A consists of exposed ash material, covered with light vegetation one to three feet in height (Photograph 55). Riprap on the north embankment near the waterline has been dislodged, apparently due to wave action (Photograph 54). Vegetation, consisting of brush and saplings, generally less than 30 inches in height, was observed on the interior slope of the north embankment (Photographs 52 and 54). The interior slopes generally appear to range from 2.5H:1V to 3H:1V. Scarps and beaching were observed on the east embankment where no armoring was present (Photographs 56 and 57). The embankment slope in these areas is approximately 1H:1V at the scarps (Photographs 56, 57 and 58).

49. Ash Pond 2A - North Embankment Interior Slope, Erosion Rill Undercuts Active Sluice Lines

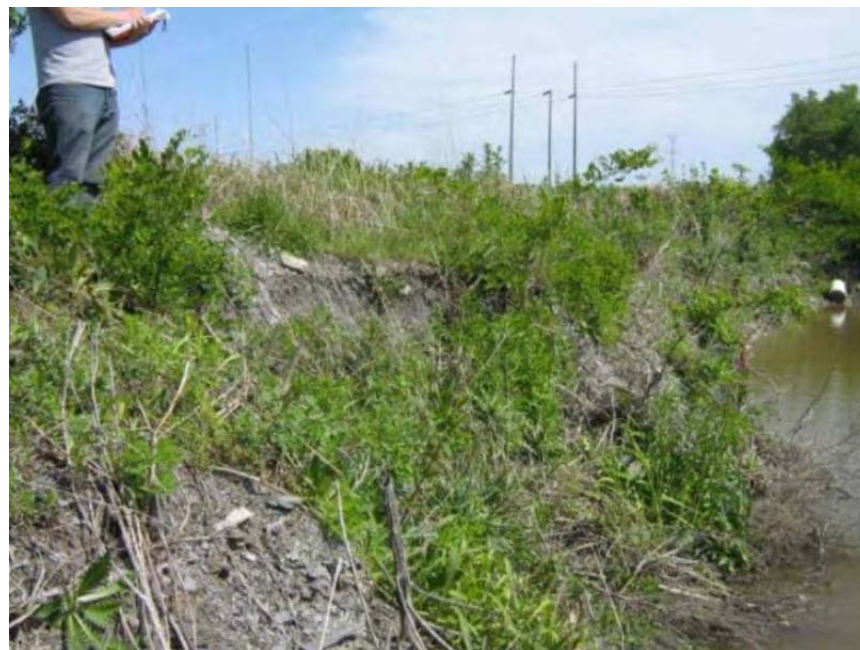
57. Ash Pond 2A - East Embankment Interior Slope, Looking South,
Slide (Scarp)

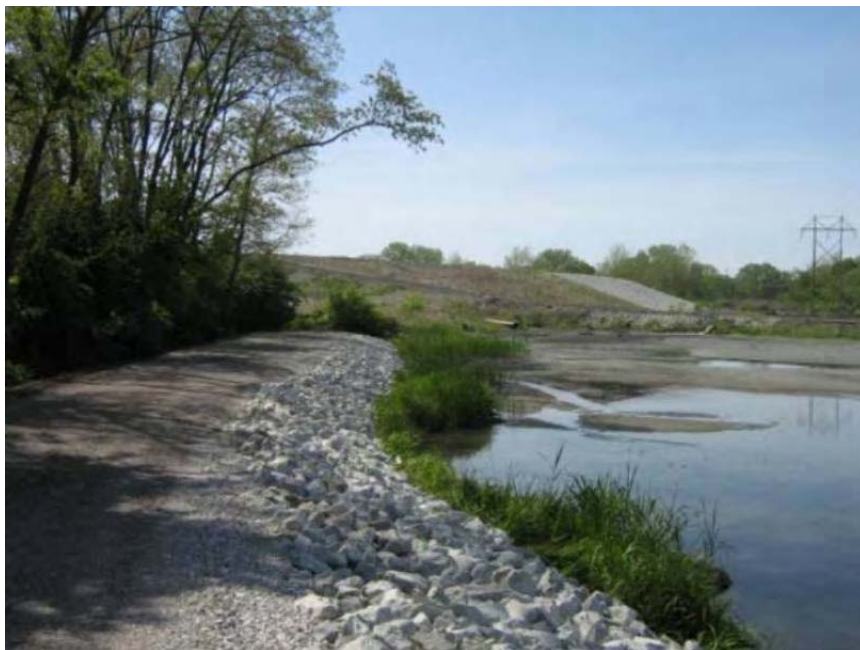
The crest appeared to be in fair condition (Photographs 51 and 61). In general, there are no signs of changes in the horizontal alignment. The crest serves as a vehicle access drive to the CCW impoundments. The average width of the embankment crest is 30 feet. A 5-foot-long section of the north embankment crest, in the vicinity of three 8-inch-diameter outfall pipes, has been eroded approximately 5 feet horizontally, resulting in a crest width of about 25 feet. This condition appears to infringe on the access drive (Photograph 46). Several minor depressions and areas of rutting were observed on the north embankment crest (Photograph 51).

The south embankment interior slope was armored with a layer of riprap to an elevation just above the water's surface (Photographs 50 and 61). Grass up to 18 inches high was observed along the waterline in this area (Photograph 60).

61. Ash Pond 2A - South Embankment Crest, Looking West

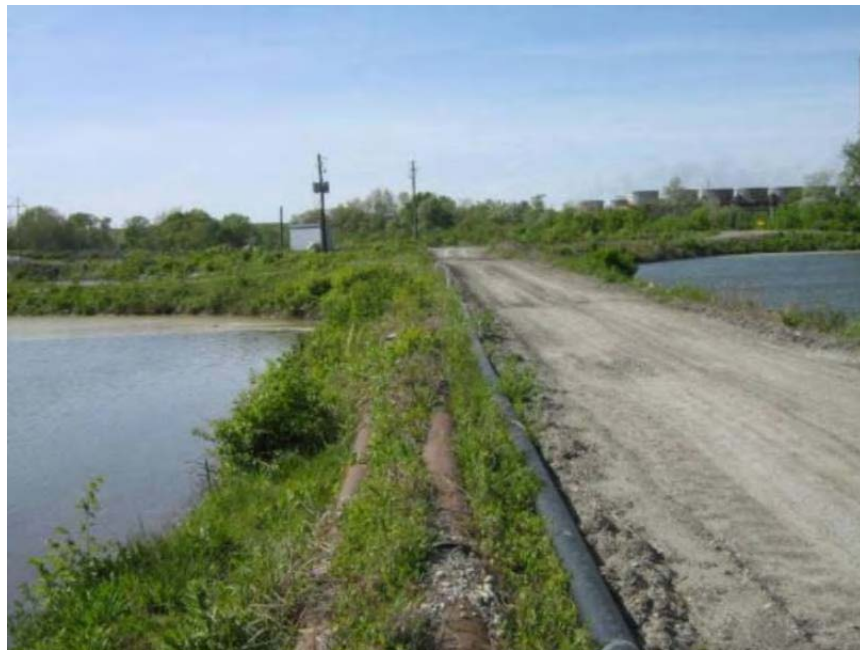
69. Ash Pond 2B - Sluice Lines (Hydroclone and Sump) along Crest and Interior Slope of East Embankment, Looking North

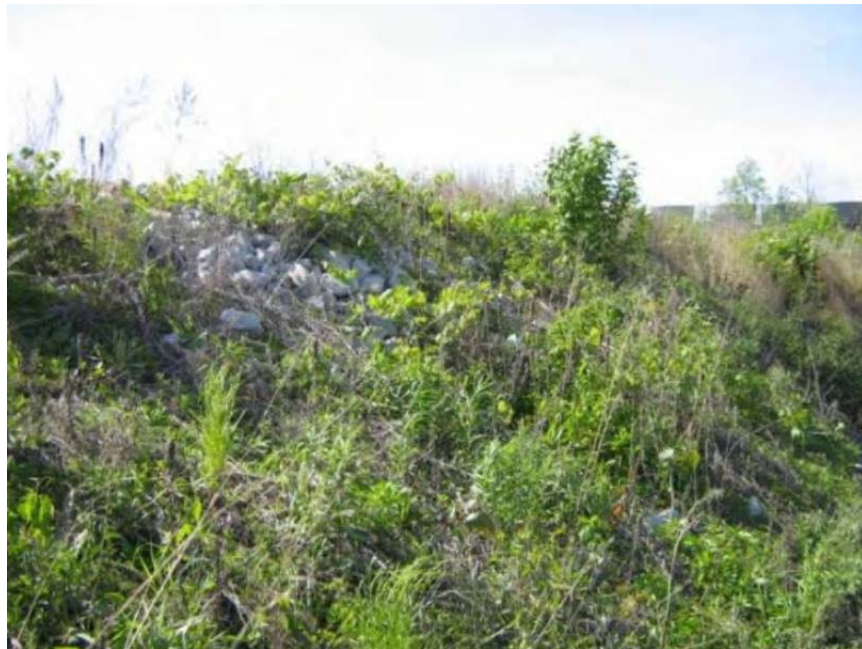
79. Ash Pond 3 - Riprap used to Stabilize Slope along West Embankment Interior Slope

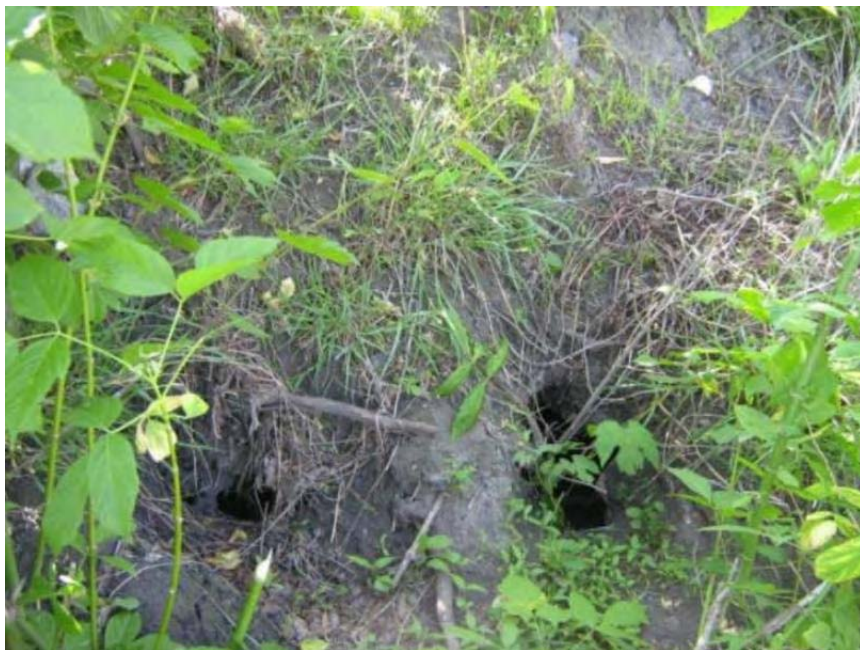
The south, east and west embankments were covered with medium dense vegetation ranging from approximately 18 to 48 inches in height. The exterior slopes on the west, south and east embankments ranged from approximately 2.5H:1V to 3H:1V. Riprap, with an underlying geotextile has been placed on sections of the east and south embankments, apparently for erosion protection (Photographs 46, 47, and 79). Surface erosion was observed along portions of the south embankment. An erosion rill on the south embankment had undercut plant sluice lines by as much as 14 inches across a distance of approximately 10 feet (Photographs 48 and 49). The east embankment had areas of erosion, including sections with apparent surficial slope failures and undermining (Photographs 78, 81 and 82).

82. Ash Pond 3 - Sink Holes on the West Embankment Interior
Slope

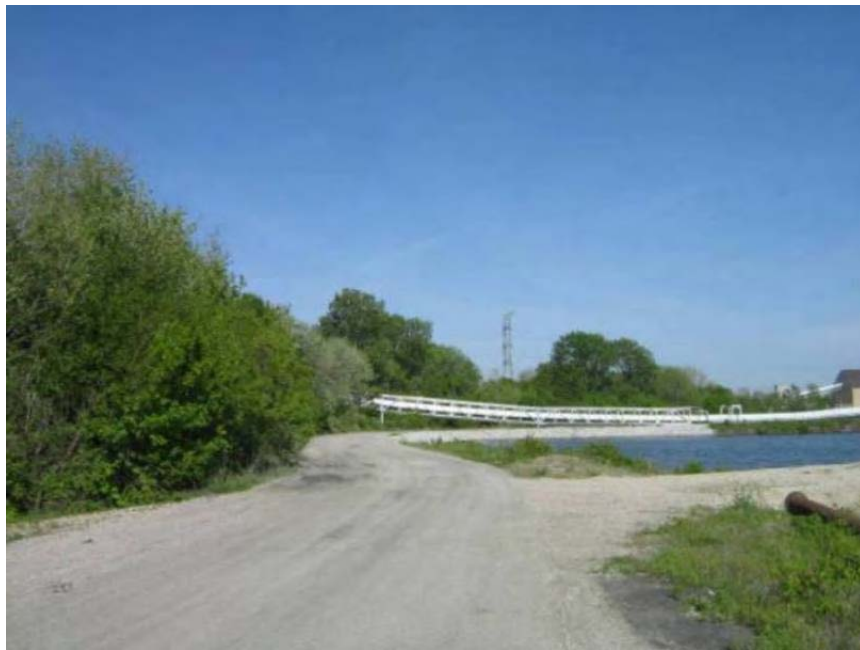
84. Ash Pond 3 - North Embankment Crest, Looking East

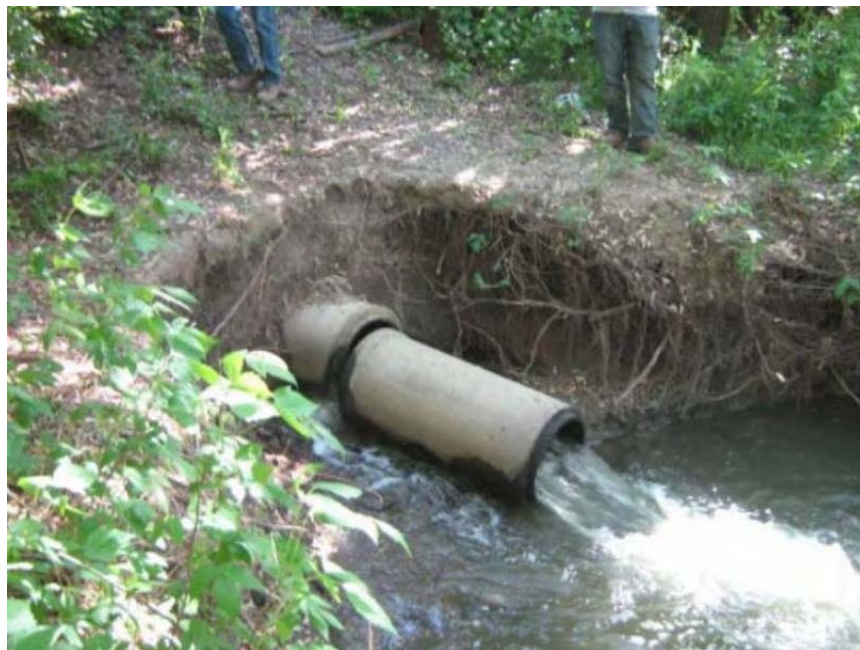
88. Ash Pond 3 - Discharge into Lick Creek, North of Ash Pond 3

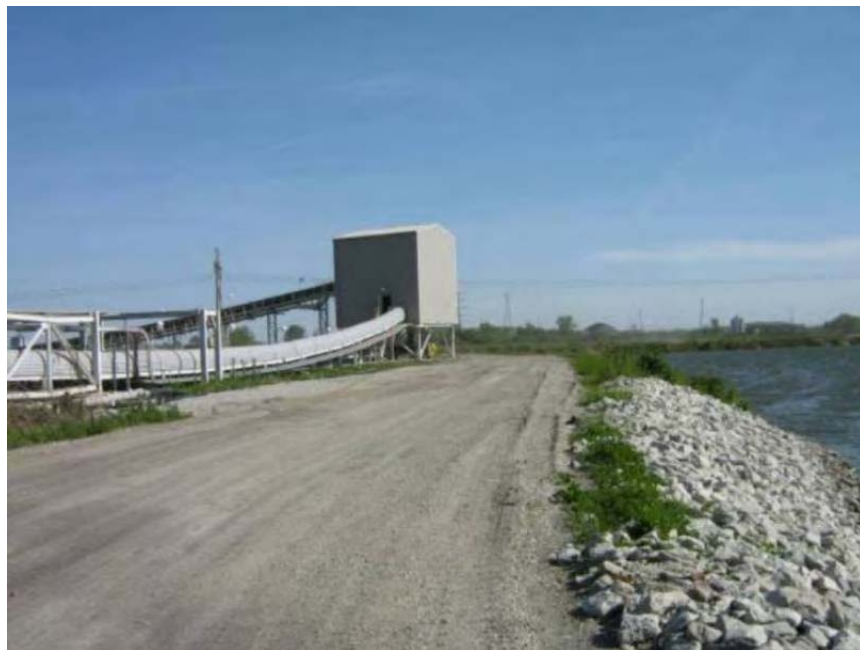
90. Ash Pond 3 - East Embankment Crest, Looking South

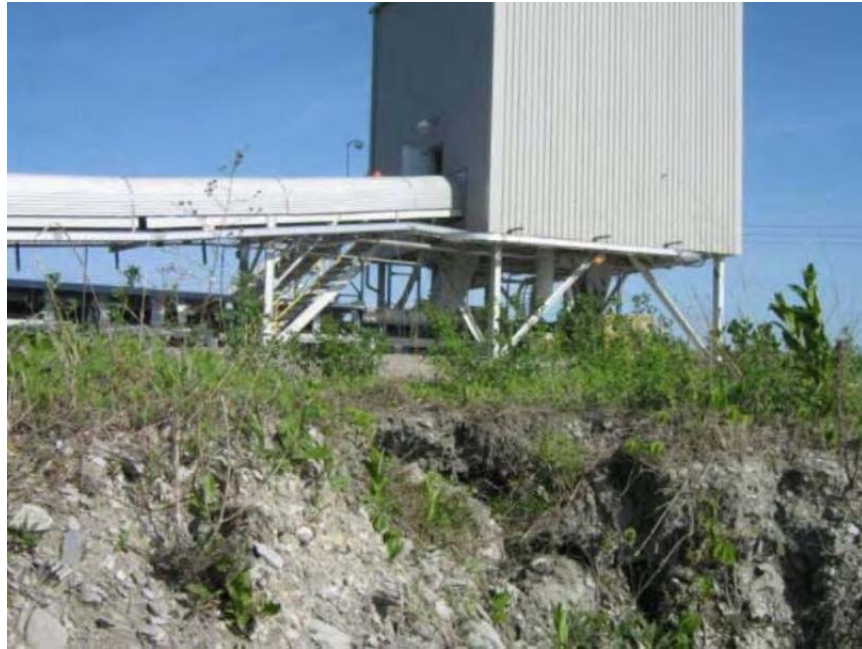
93. Ash Pond 3 - Erosion Rills on top of East Embankment Interior Slope

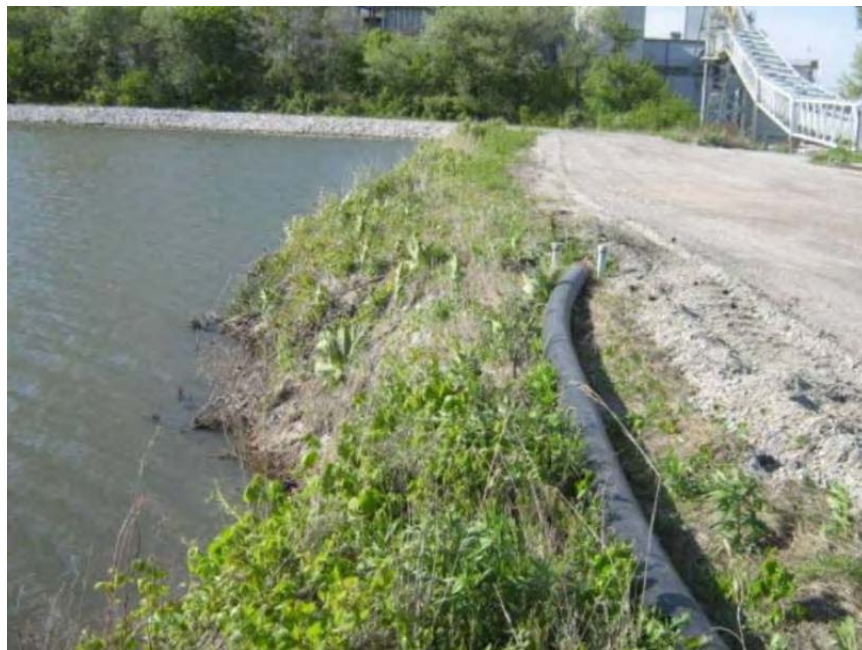
Vegetation was observed on the north embankment (Photographs 80 and 85); the east embankment (Photographs 91, 94 and 95); the south embankment (Photograph 96); and the west embankment (Photographs 76, 81, and 101).

94. Ash Pond 3 - Slope Erosion along East Embankment Interior Slope so as the Distance between the top of Slope and Hydroclone pipe is Approximately 2 feet

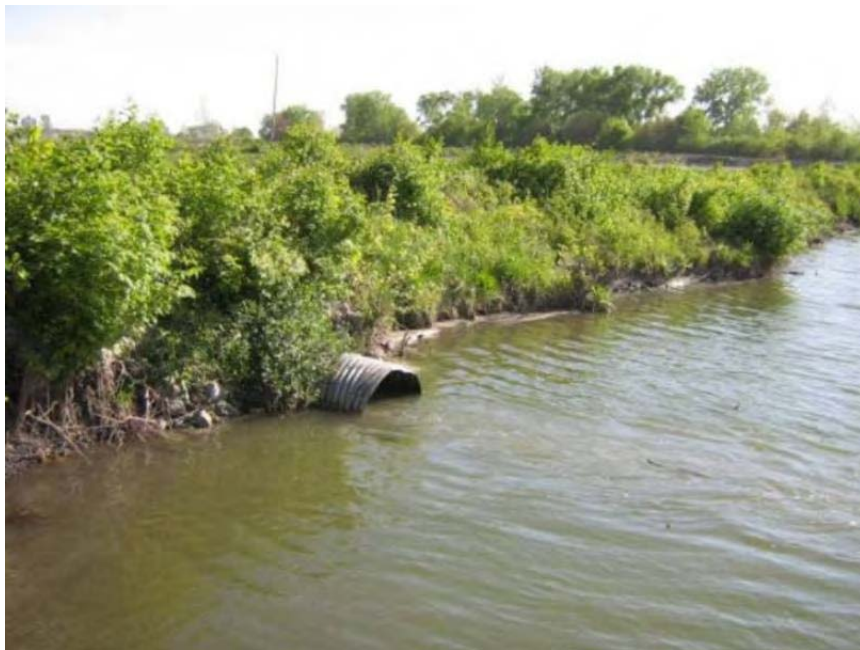
96. Ash Pond 3 - Inflow from Ash Pond 4A Located at Southeastern Corner of Pond

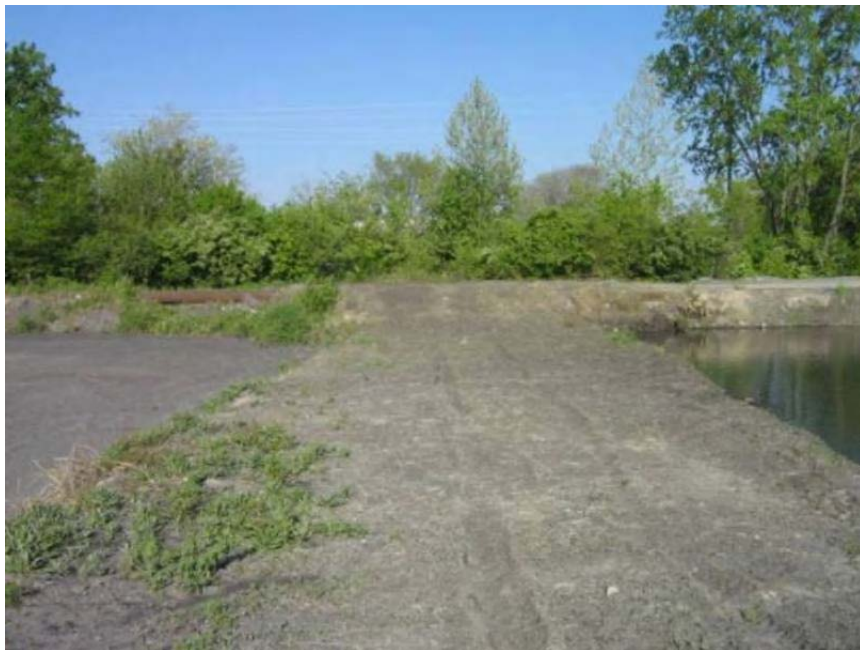
108. Ash Pond 4 - North Embankment Crest, Looking West

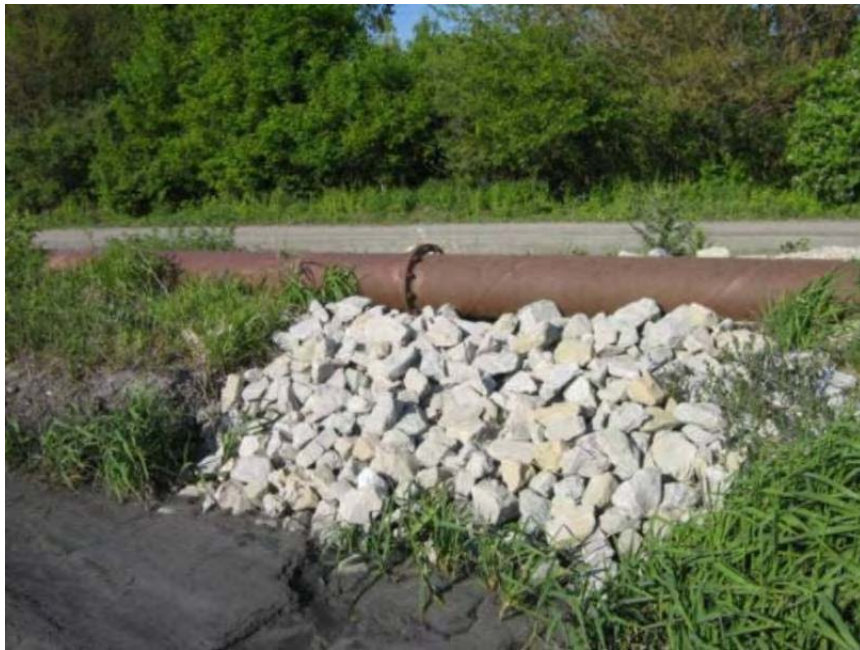
112. Ash Pond 4 - West Embankment Interior Slope, Riprap under
Sluice Line to Address Undercut

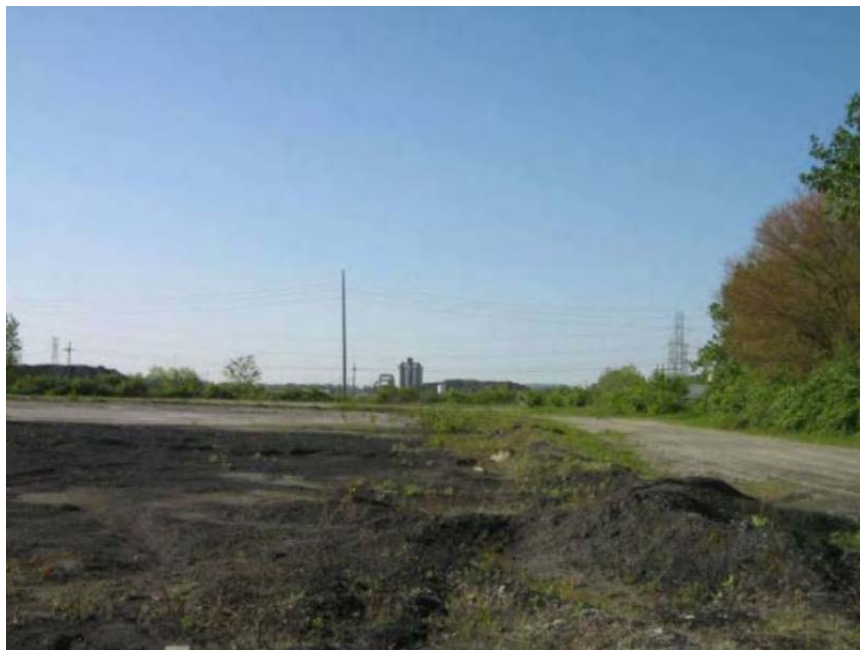
118. Ash Pond 4 - West Embankment Interior Slope, Looking South,
Ash Sediment Near top of Crest

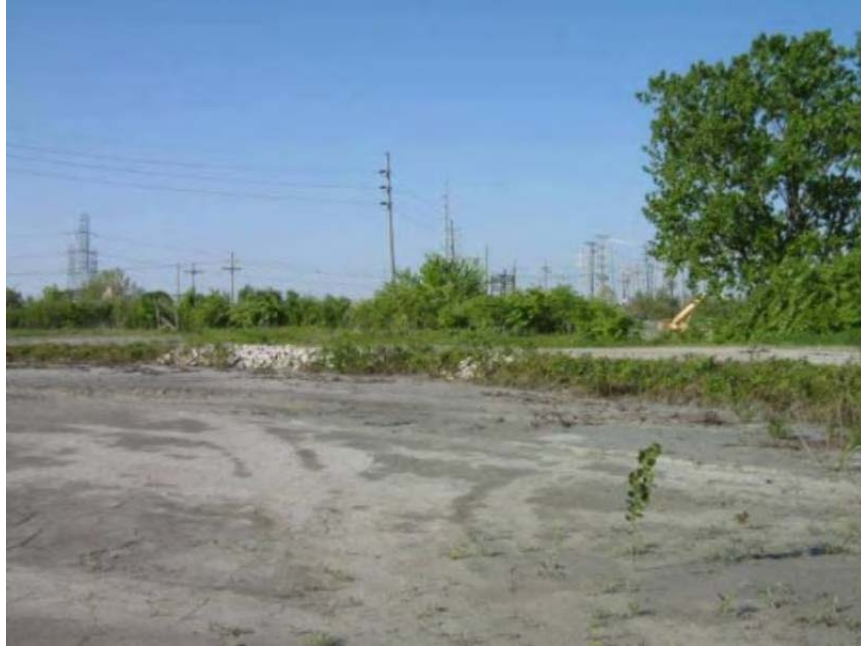
119. Ash Pond 4 - Riprap used to Repair Erosion at Western Embankment Interior Slope

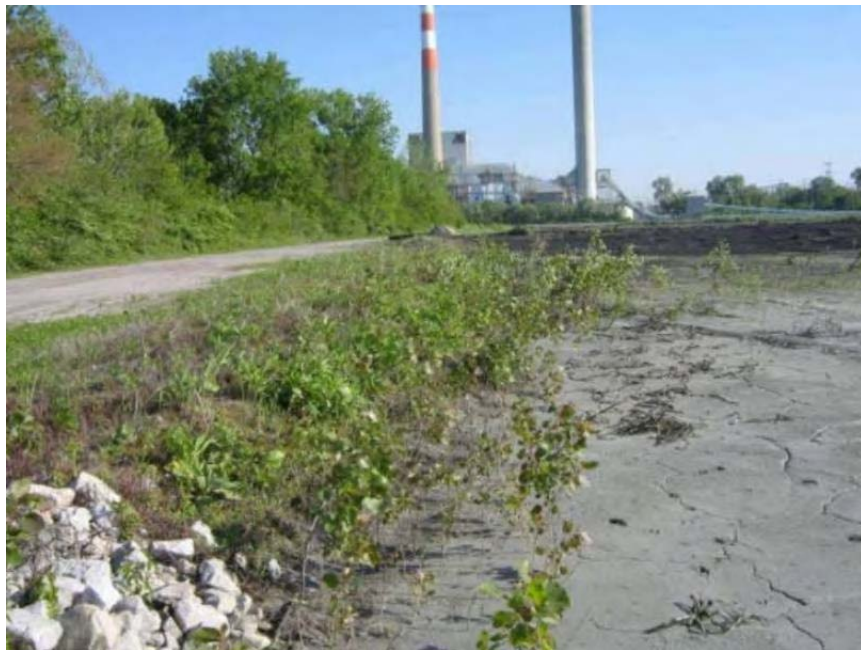
120. Ash Pond 4 - Vegetation along West Embankment Interior Slope, Looking North

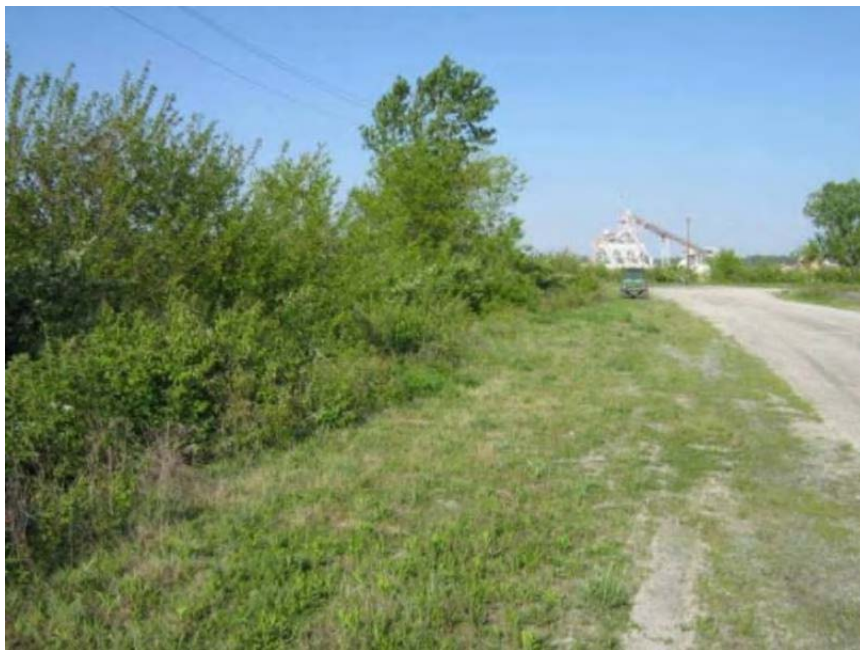
124. Ash Pond 4 - South Embankment Exterior Slope, Looking
West, Heavy Vegetation Present

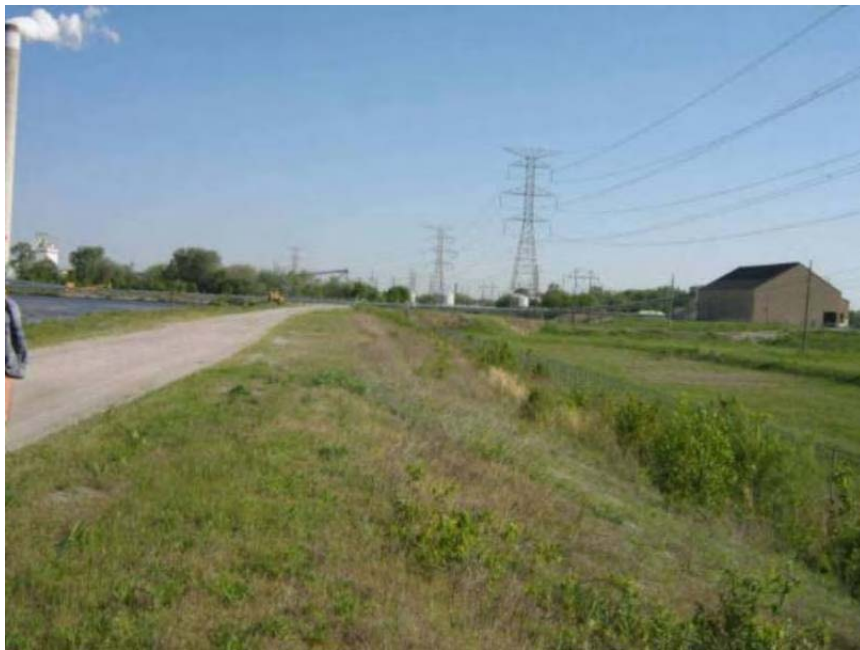
128. Ash Pond 4 - East Embankment Exterior Slope, Looking North,
Established Vegetation on Slope, Brush and Saplings at Base of Slope

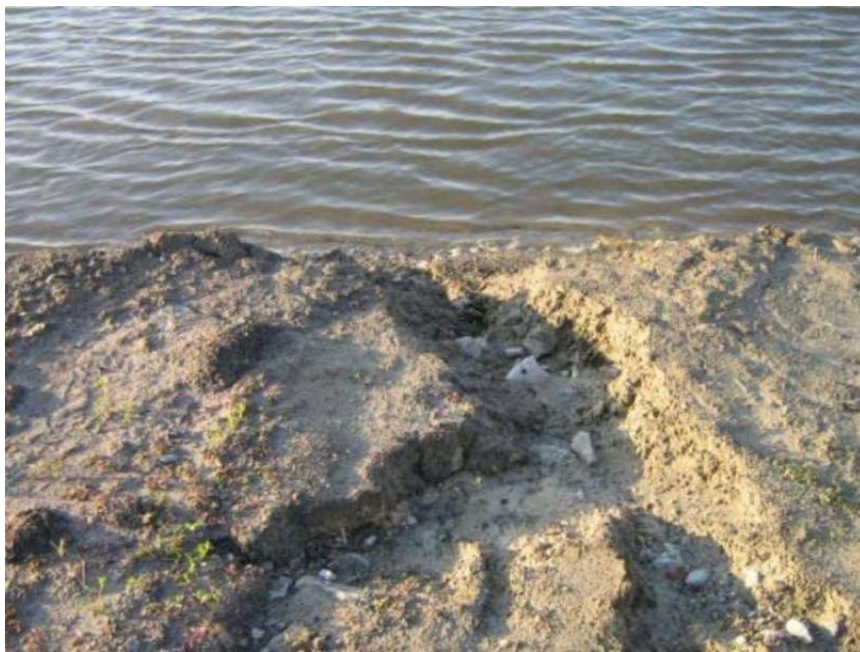
140. Ash Pond 4A - Erosion Rill on North Embankment Interior Slope

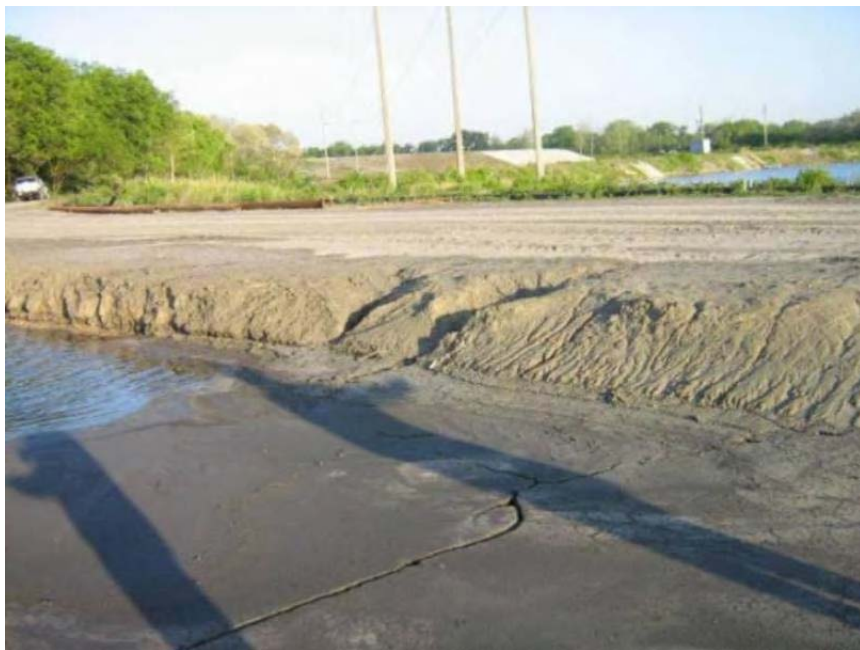
142. Ash Pond 4A - Erosion Rills on North Embankment Interior Slope, Looking Northeast from Pond

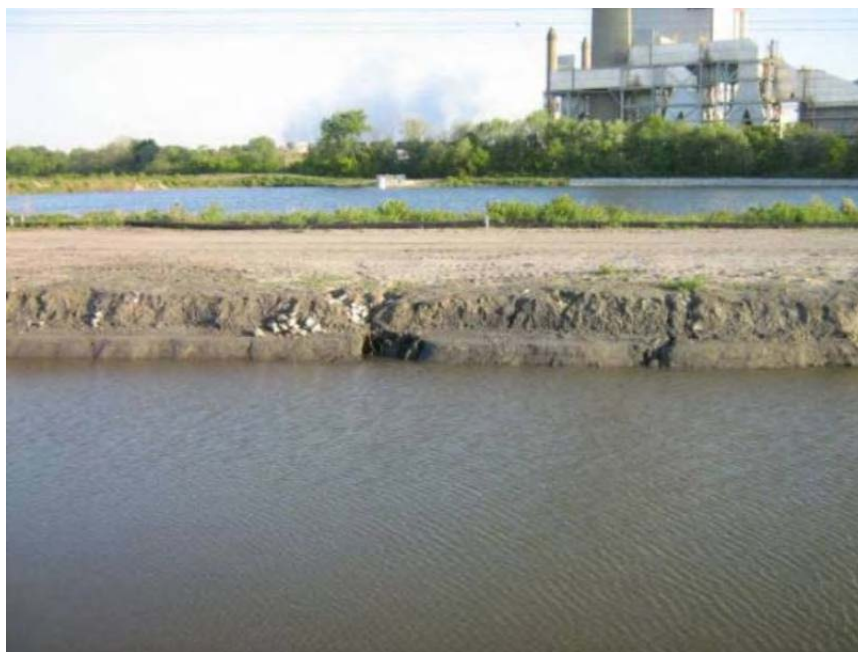
146. Ash Pond 4A - Erosion Rills and Beaching along North Embankment Interior Slope, Looking North

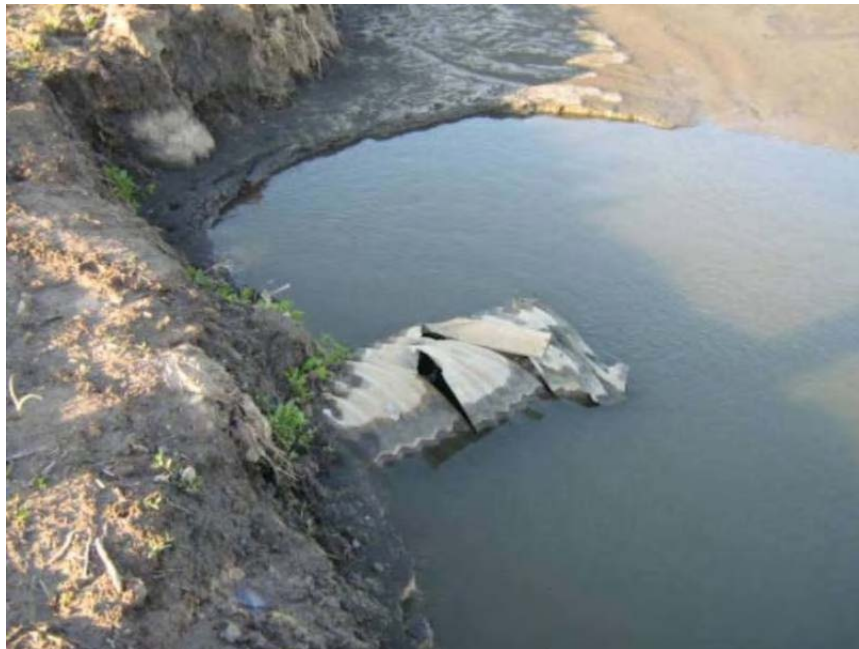
149. Ash Pond 4A - Inlet/Outlet to Ash Pond 4B at Southeastern
Corner of Pond, Damage to 30-inch-Diameter CMP Visible
